In addition to the inevitable public debate that the M1 Garand's successor faced as a follow-on military rifle, its designers were kept busy solving some little-known but nagging faults.

EARLY PROBLEMS WITH THE M14 RIFLE

BY ALBERT A. COLE, JR.

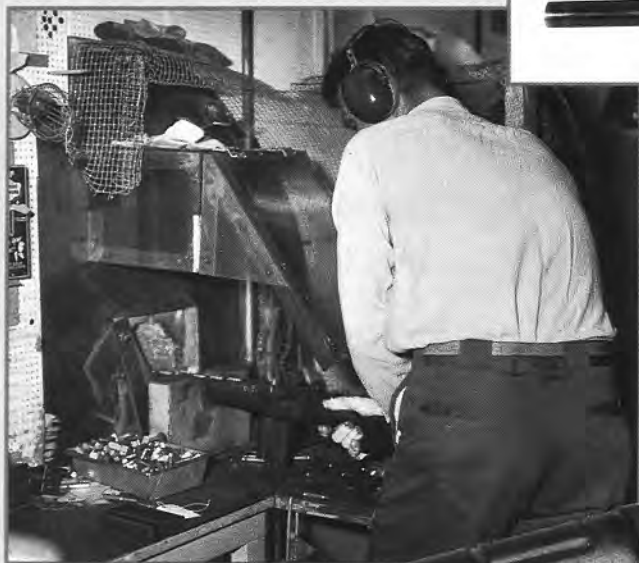
Springfield Armory's experts solved a feeding problem by taking .1" off the operating rod stop face, reducing the gun's cyclic rate.

If the operating rod were cut away so that it would travel further rearward, then the recoiling bolt could bounce off the receiver, hit the still-traveling-rearward operating rod, and the resulting clash would slow down the whole mechanism. Then the operating rod, with the bolt, would move forward into battery more slowly.

To test the theory, about .1" was taken off the operating rod. It was test fired, and it worked. The high cyclic rate of 1000 rounds per minute, or more, was slowed to 650 to 780 rounds per minute, at which rate the magazine spring had time to position the next round properly.

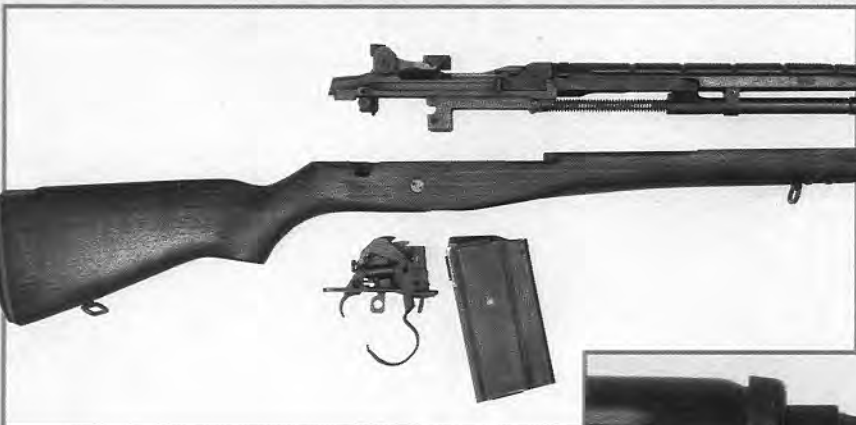
A National Match M14 illustrates the unvented handguard that replaced the vented version pulverized by drilling Marines.

In the category of field usage, the design and redesign of the handguard was an unanticipated problem. The first plastic handguards contained elongated slots on the top side to allow barrel heat to dissipate.

The next step was to thicken the material in the handguard. This was a more costly and time-consuming die change, and it was a while before the Marines saw the new version. But, when they got it, they found it had solved their problem. The handguard thickness had been increased from an average of .070" to .090".
